Intel® Mobile Celeron™ Processor at 500 MHz, 450 MHz, and 400A MHz Specification Update

Release Date: March 2000

The Intel® Mobile Celeron™ processor at 500 MHz, 450 MHz, and 400A MHz may contain design defects or errors known as errata which may cause the product to deviate from published specifications. Current characterized errata are documented in this Specification Update.

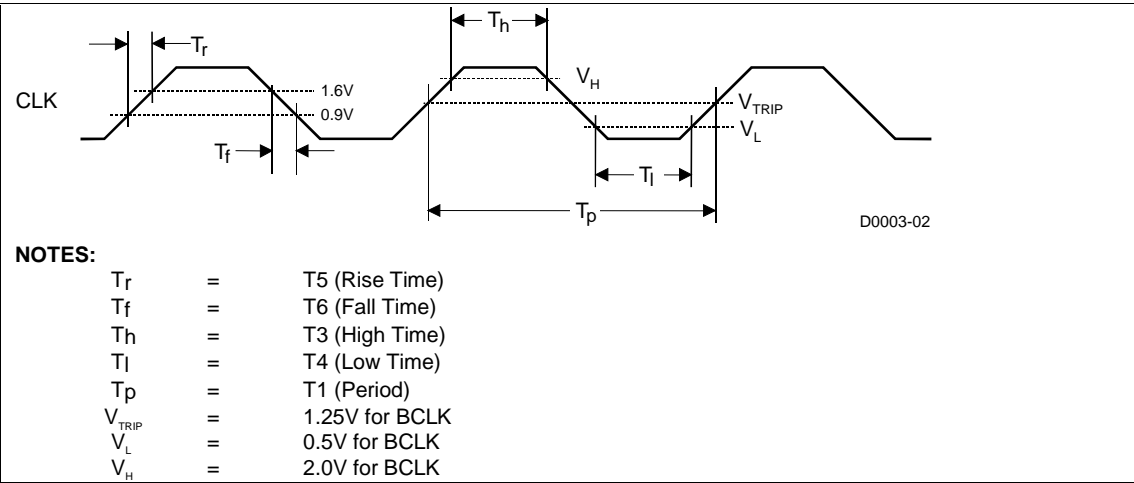
Figure 6. BCLK Timing Waveform

Symbol	Parameter	Min	Typ	Max	Unit	Figure	Notes
	System Bus Frequency		100		MHz		
T1	BCLK Period		10		ns	Figure 6	Note 2
T2	BCLK Period Stability			± 250	ps		Notes 3, 4
T3	BCLK High Time	2.70			ns	Figure 6	at >2.0V
T4	BCLK Low Time	2.45			ns	Figure 6	at <0.5V
T5	BCLK Rise Time	0.175		0.875	ns	Figure 6	(0.9V – 1.6V)
T6	BCLK Fall Time	0.175		0.875	ns	Figure 6	(1.6V – 0.9V)

1. All AC timings for GTL+ and CMOS signals are referenced to the BCLK rising edge at 1.25V. All CMOS signals are referenced at 0.75V.
2. The BCLK period allows a +0.5 ns tolerance for clock driver variation.
3. Not 100% tested. Specified by design/characterization.
4. Measured on the rising edge of adjacent BCLKs at 1.25V. The jitter present must be accounted for as a component of BCLK skew between devices.

For B0 step processors, the $V_{IH,BCLK}$ Min spec is changed to 2.0V (from 1.7V for A2 step) and $V_{IL,BCLK}$ Max spec is changed to 0.5V (from 0.7V for A2 step). Due to this, new values are specified for BCLK high and low times for B0 step processors. These modifications affect corresponding specs in Table 12, Table 13, Table 22, and Figure 6 in *Mobile Celeron™ Processor in BGA2 and Micro-PGA2 Packages at 500 MHz, 450 MHz, and 400A MHz* datasheet.
